Icom IC-765 Notes

Don Stalkowski, VE3HUR

December 17, 2005

Version 1.08

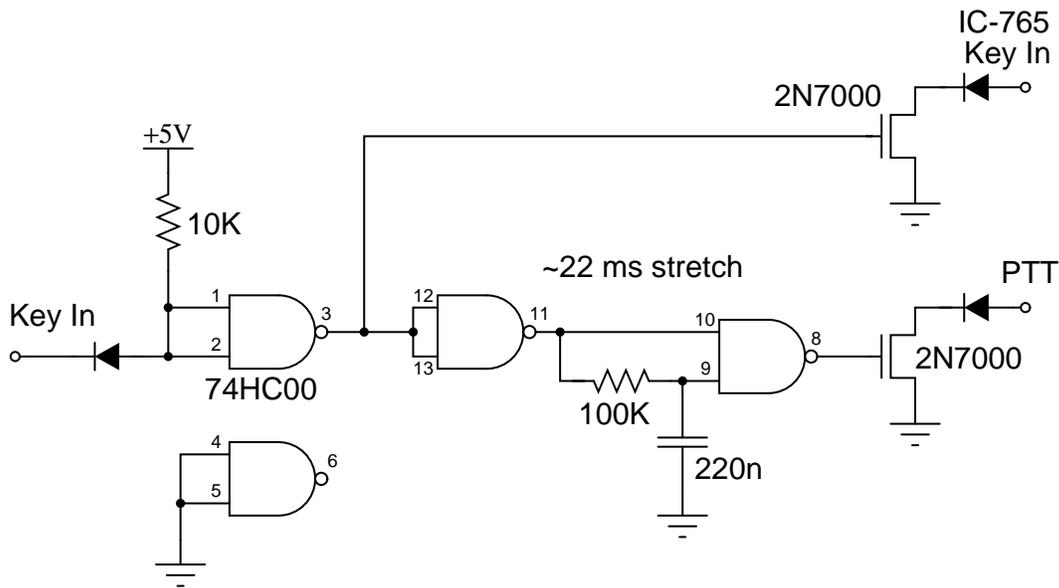
Figure 9: VE3ZI QSK Adapter

The PTT timing when using full break-in or fast key operated changeover is faulty. When you press the key, PTT goes low almost immediately, but RF does not happen for about 10 ms. This is fine and allows time for just about any full-break-in-capable amplifier to change over. When you release the key, PTT goes high almost immediately, but RF does not stop for another 10 ms. (This is low level PTT from the ACC socket - the SEND relay is not quite as bad, presumably because of its operating delay. But it is also the internal PTT function within the IC-765 and causes clipped dots when using full break-in). So, one is almost bound to hot switch on break. The fundamental reason for the problem is that PTT on all modes is derived from the VOX circuitry and CW keying uses totally separate timing and circuitry.
