Note: You can confirm that the PA RF FETs are defective by removing the top cover and watching the fan that is mounted on the power supply assembly. If the fan does not start up when the unit is turned on, the FETs are shorting the 48V supply and the power unit output is inhibited.

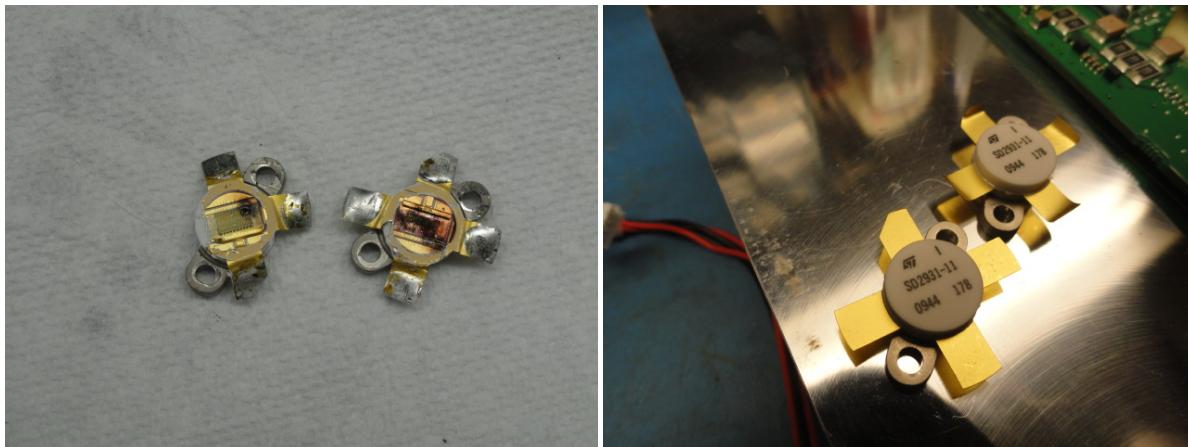
I removed the caps from the two FETs that came out of my 7851...you can see the damage they sustained when I turned the radio on...I don't know why it happened...

The second photo shows a small turn-up I put on the new FETs so that they are easier to remove if / when this failure happens again!

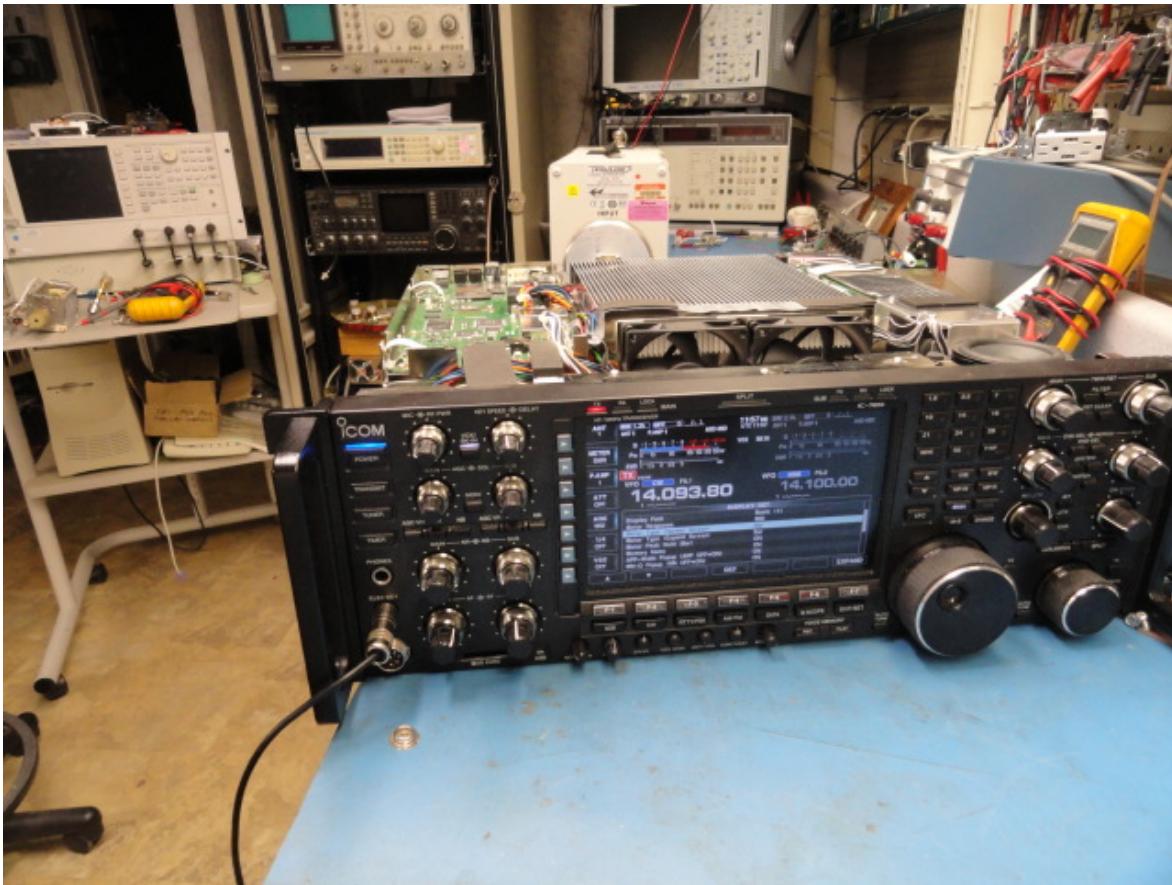
I tested the radio after repair before I put the covers back on, you may consider doing the same just to make sure everything is working...200W into a 50 Ohm load
